**EPA Superfund
Expanded Site Inspection:**

**SMOKEY MOUNTAIN SMELTERS
EPA ID: TN0002318277
09/01/05
KNOX COUNTY, TN**

EXPANDED SITE INSPECTION

September 2005

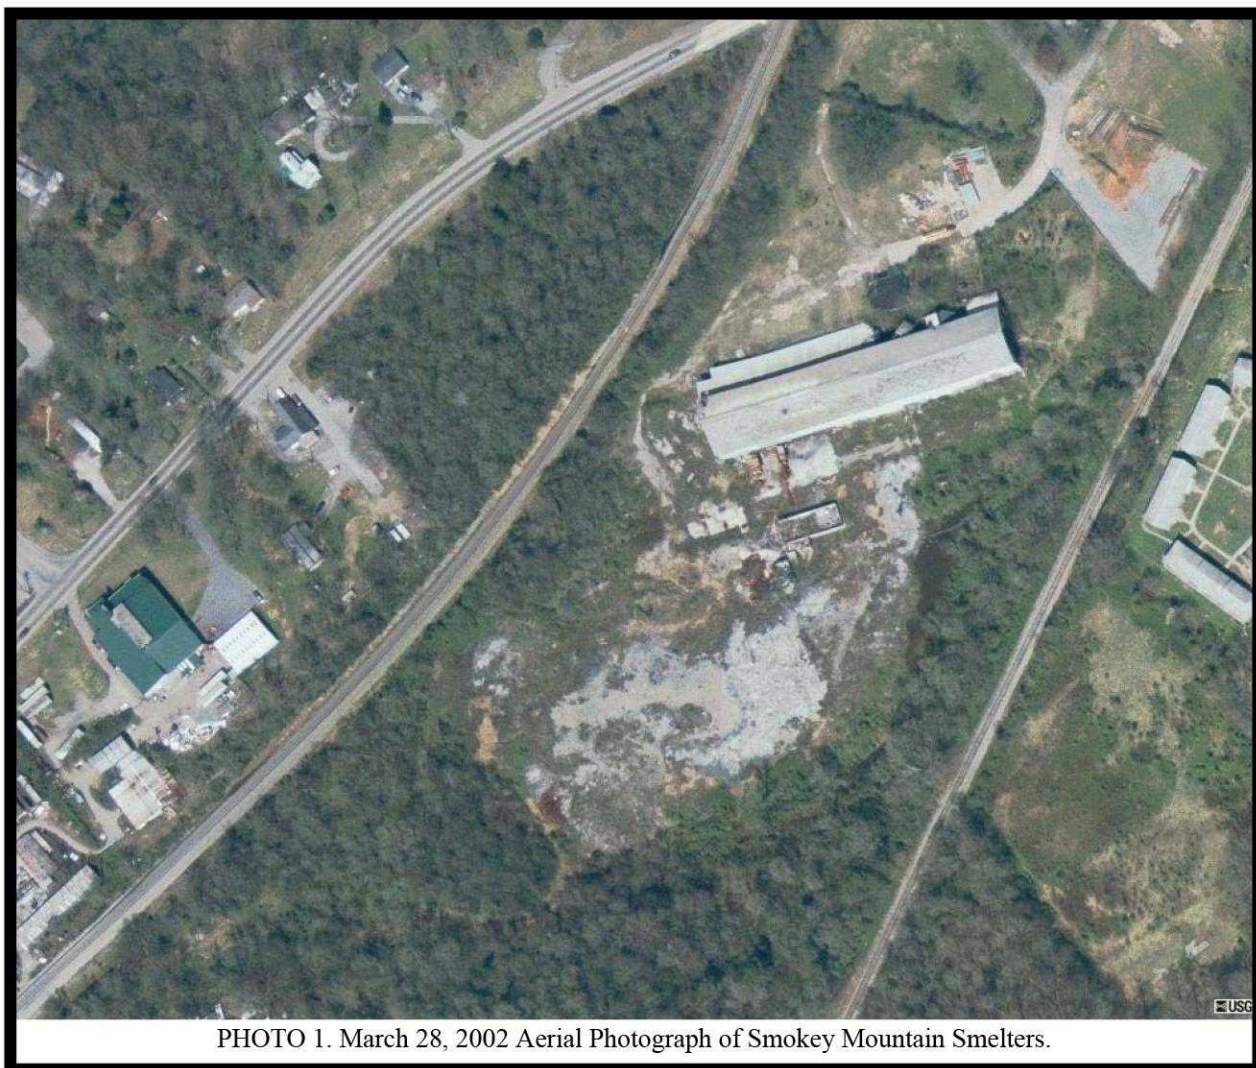
PHOTO 1. March 28, 2002 Aerial Photograph of Smokey Mountain Smelters.

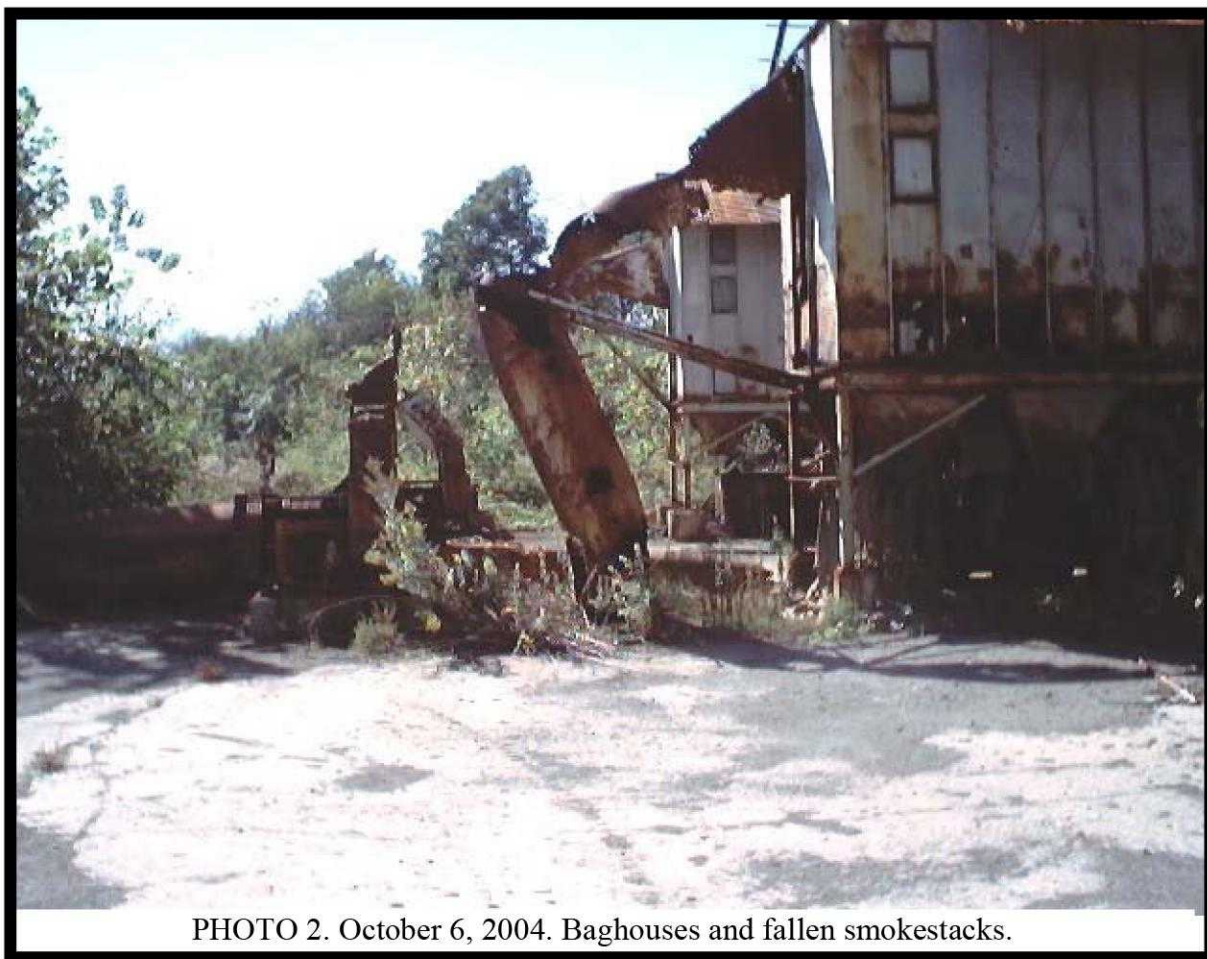
PHOTO 2. October 6, 2004. Baghouses and fallen smokestacks.

Large, black, carbon-like blocks which may bear a resemblance to anode or cathode wastes from aluminum production were observed at the Site during numerous inspections by the TDOR beginning in 1997. Baghouses and baghouse dust from secondary aluminum smelting and casting are present. Dross and slag (Ref 5) from aluminum production is present. Other

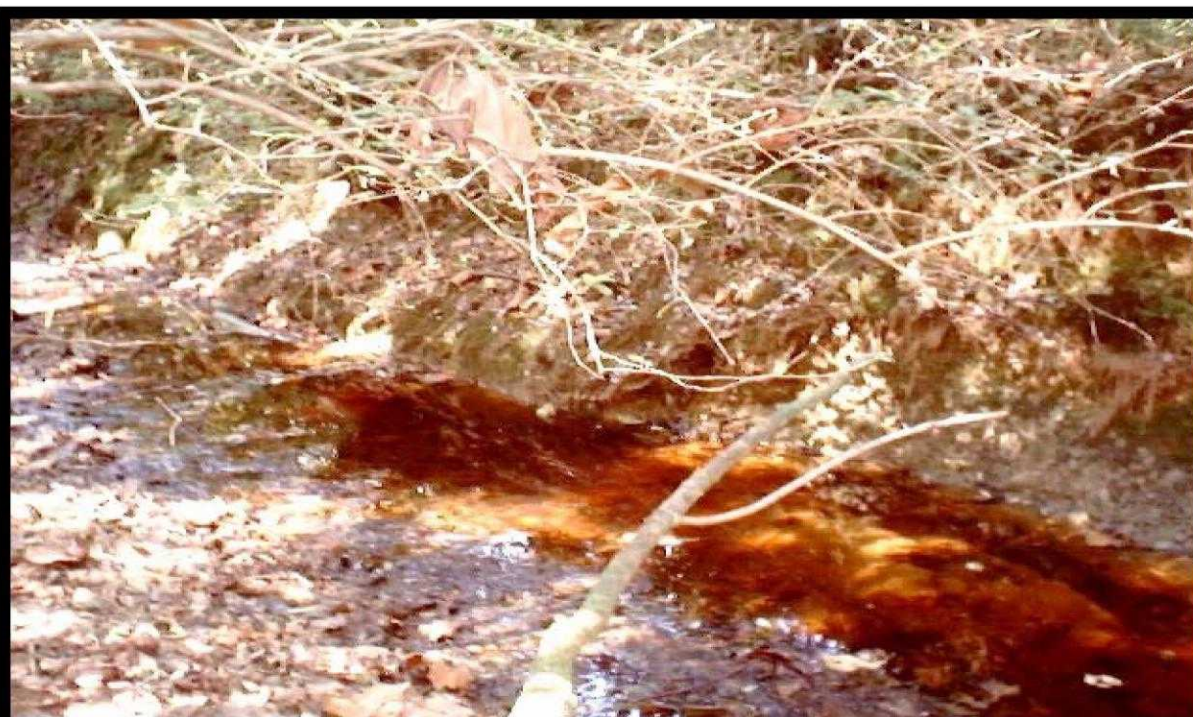
in several containers located under the two baghouses. Four samples were collected from waste piles outside the process building. The other two samples were collected from a leachate spring at the point of exit from a waste pile, indicated on Figure 3C. Discoloration of the receiving stream caused by the leachate is shown in Photo 2.

PHOTO 3. 12:45 pm, October 6, 2004. East East Branch of Flenniken Branch immediately after the confluence with a stream containing leachate from waste at the Smokey Mountain Smelters Site. Location of Phase 2 samples SW-11 and SW-19. Flow is from right to left.

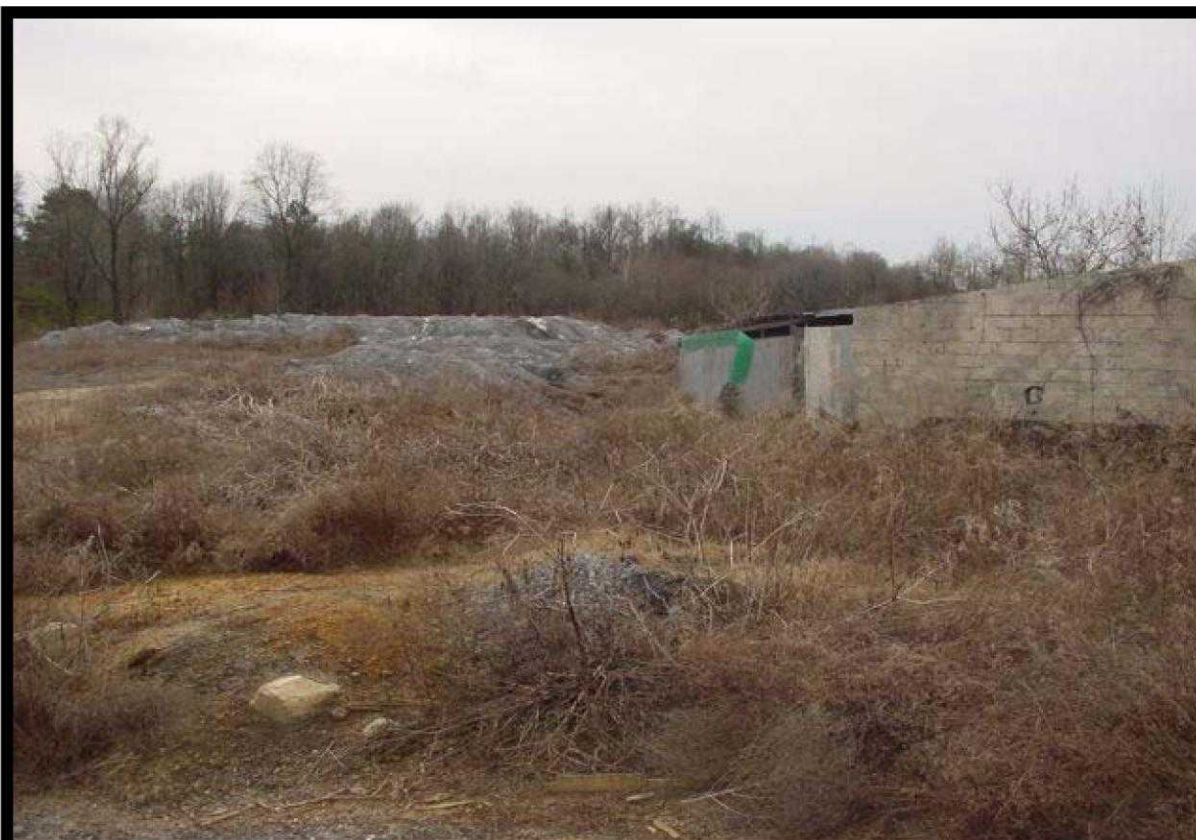
Photo 4 (top) Outside waste pile. Looking to the south past the maintenance building. February 5, 2002.

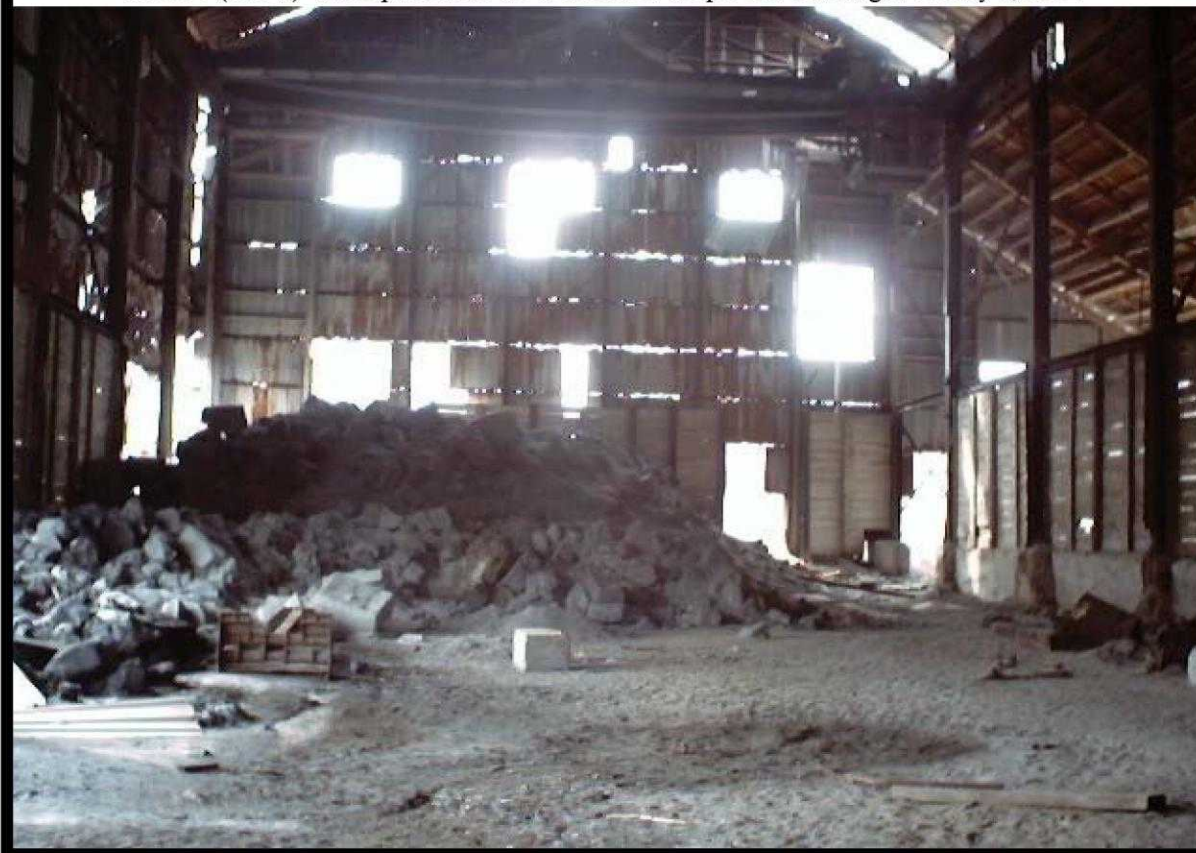
Photo 5 (below) Waste pile inside the west end of the process building. February 5, 2002.

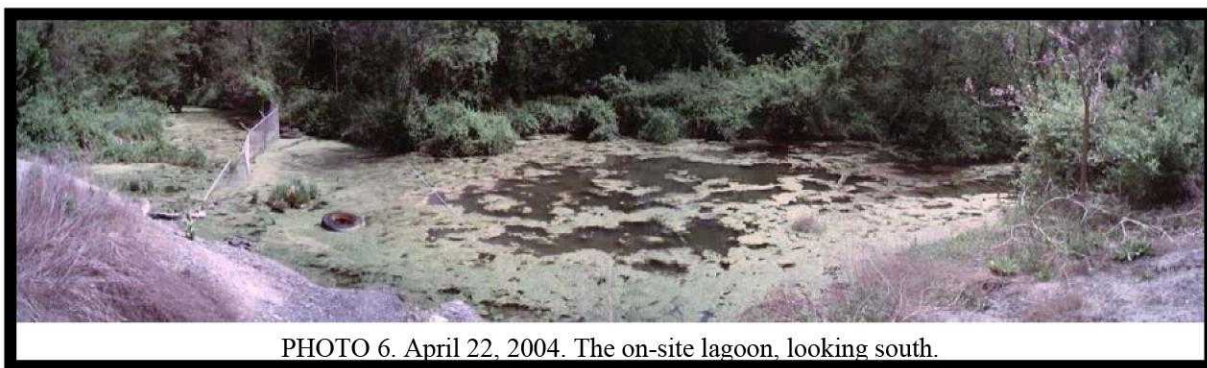
PHOTO 6. April 22, 2004. The on-site lagoon, looking south.

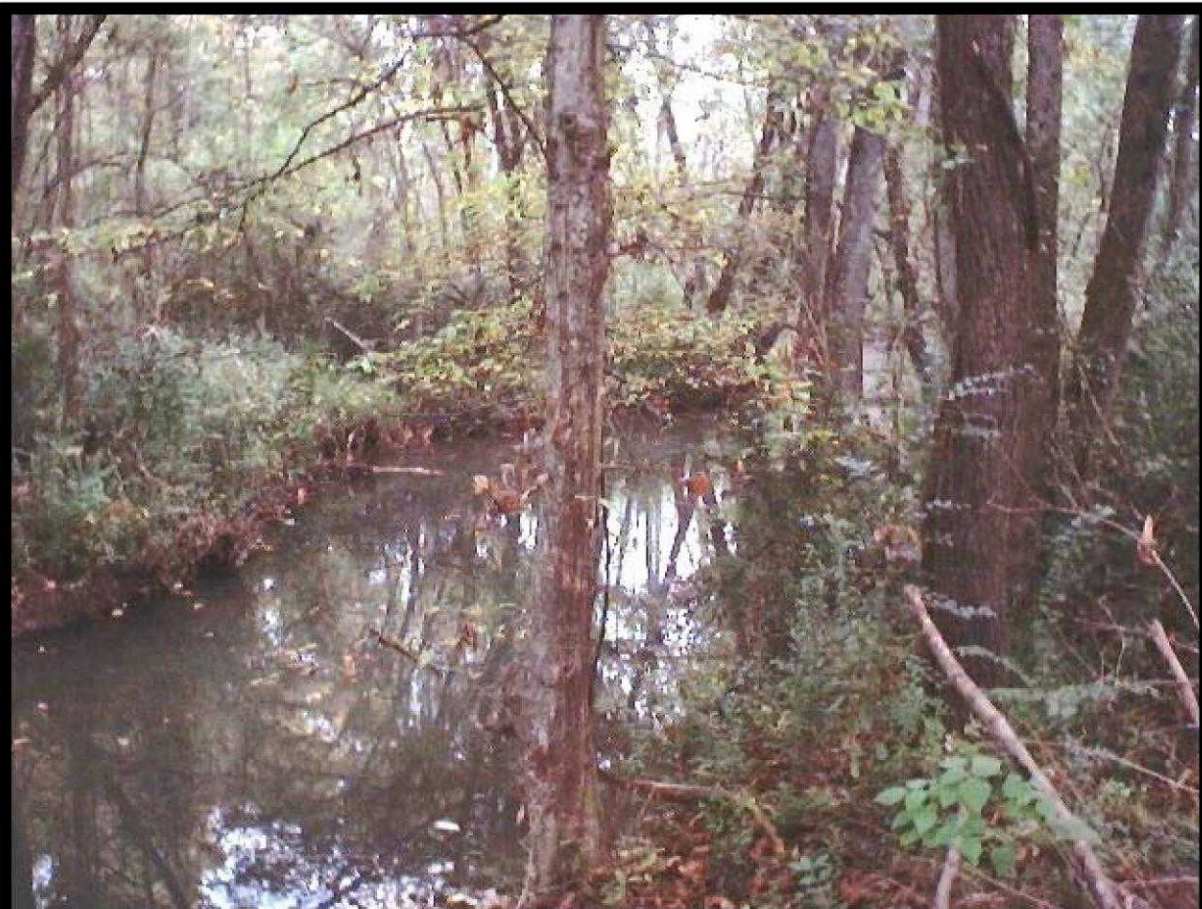
PHOTO 7. October 6, 2004.

Looking upstream at Flenniken Branch at the Knob Creek/Tennessee River embayment 1/8 mile distant from the parking lot at I.C. King Park and 1.6 mile from the Site.

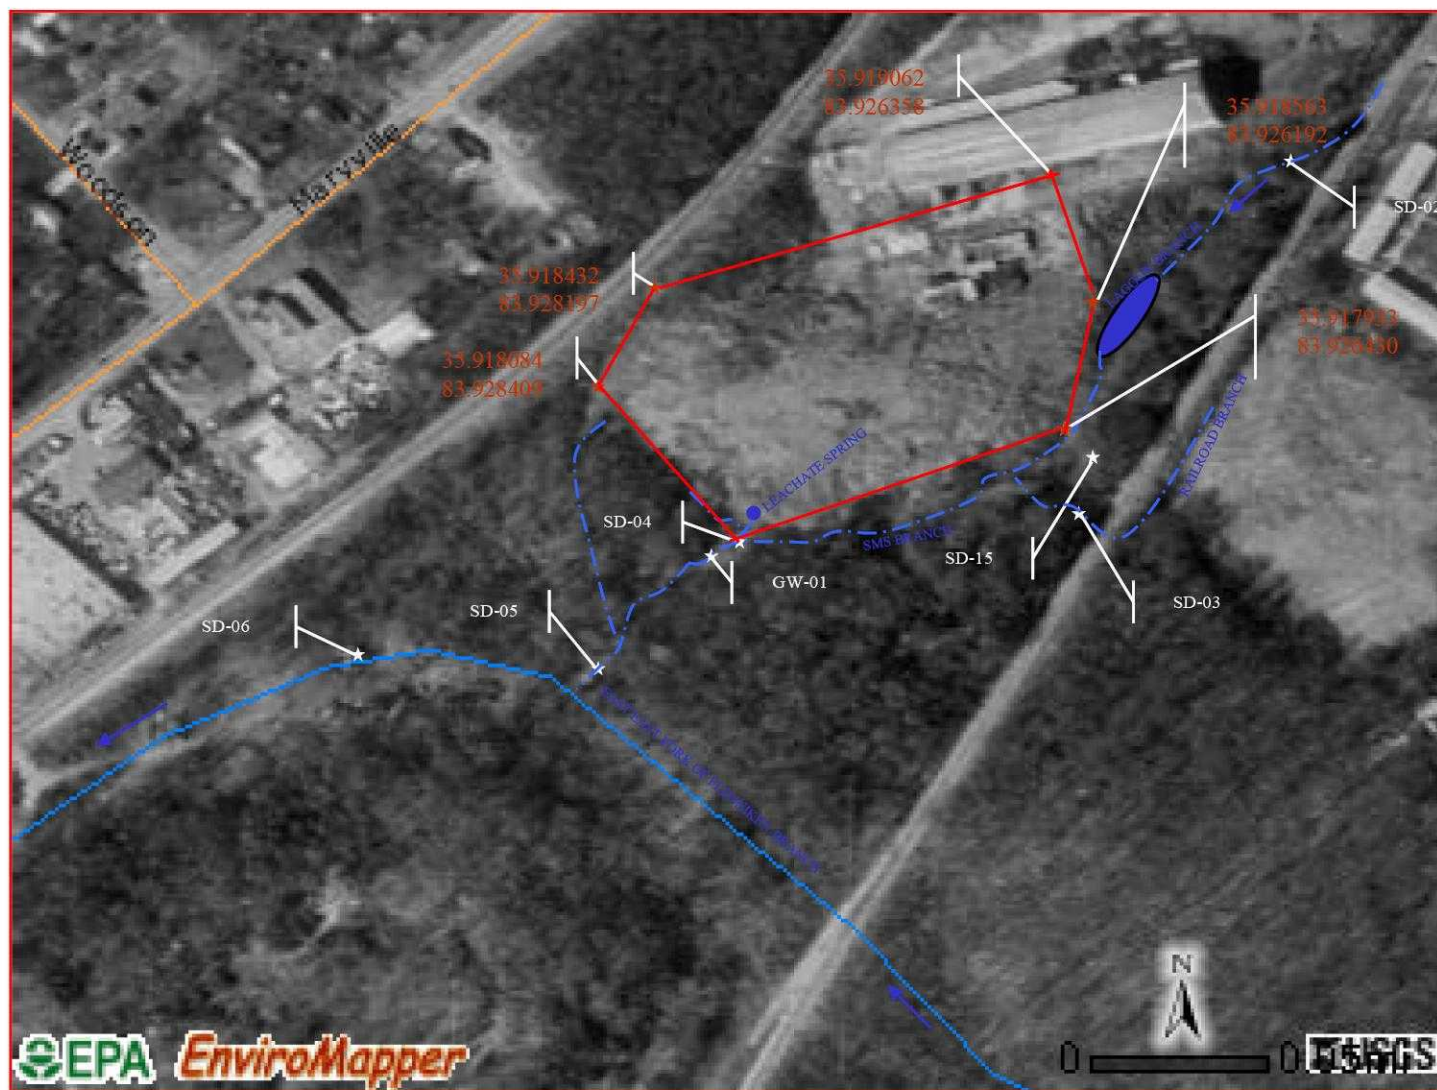
Smokey Mountain Smelters Site / Knoxville, TN Photo date: 03/07/97 0 ----- 0.05mi

FIGURE 3C selected sample locations / waste pile boundary coordinates / on-site drainage patterns
